Manhole Inspection Summary

Manhole # S39A2_013MH

Insp Date: **12/26/07 8:11 AM**

Location Address: **515 E Jeffrey St**

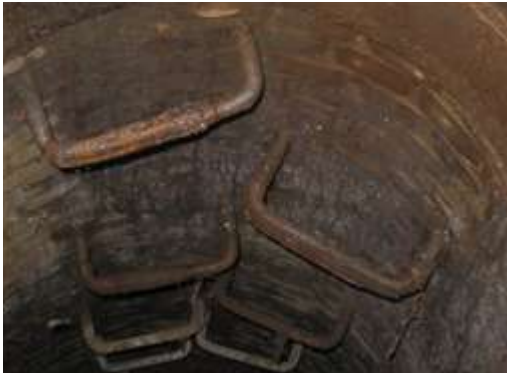
Steps Count: **7** Missing: **0** ☒ **Corroded**

steps

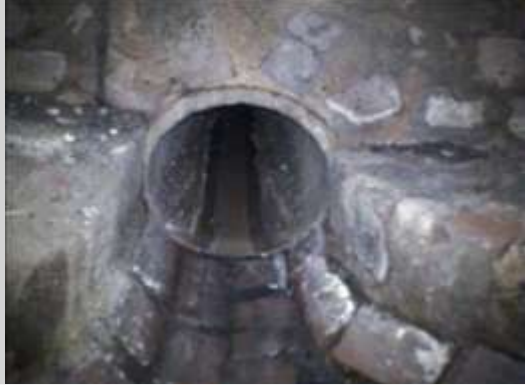
12 O'Clock Outflow

8 in. Circular Gravity Sewer
Pipe Out @ 12 O'Clock

Pipe Height: **9.6** (in.) Rod and Bar (Angled)
Pipe Material: **Clay** ☐ Pipe Lined
Invert Depth: **12.20** (ft.) Flow Characteristics: **Fast**
Deposits: ☒ None ☐ Mud ☐ Sludge ☐ Debris ☐ Grease
Silt Depth: (in.) Deposits Extent:
Infiltration: **None** Pipe Seal Cond: **Sound**

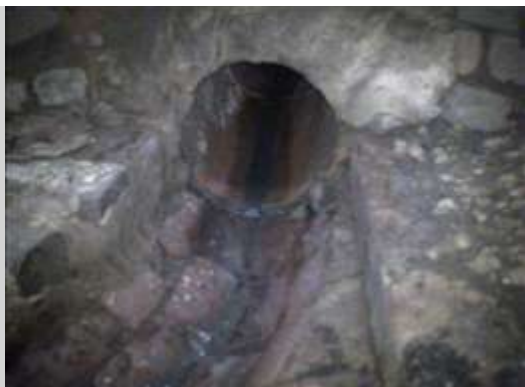
3 O'Clock Inflow

6 in. Circular Service Sewer
Pipe In @ 3 O'Clock

Pipe Height: **9.6** (in.) Rod and Bar (Angled)
Pipe Material: **Clay** ☐ Pipe Lined
Invert Depth: **11.73** (ft.) Flow Characteristics: **Fast**
Deposits: ☒ None ☐ Mud ☐ Sludge ☐ Debris ☐ Grease
Silt Depth: (in.) Deposits Extent:
Infiltration: **None** Pipe Seal Cond: **Sound**

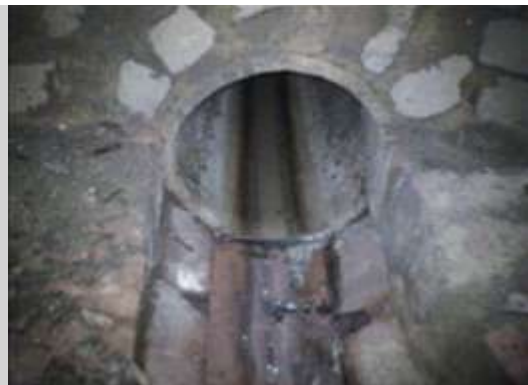
9 O'Clock Inflow

8 in. Circular Service Sewer
Pipe In @ 9 O'Clock

Pipe Height: **8.4** (in.) Rod and Bar (Angled)

Infiltration: **None** Pipe Seal Cond: **Sound**

Connects To: **Dead End**
